Engine Liner Mapping

Next Generation Engine Liner Measurements for marine 2-stroke engines

02nd March 2021 – Hamburg

Presentation by Birk Fleischer – CTO – Tenaro GmbH Hamburg, Germany

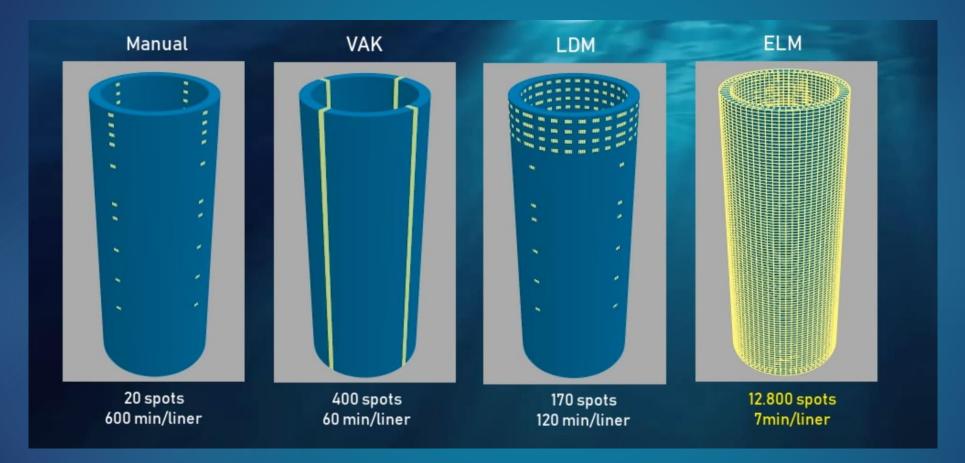
Alternatives ?

Other methods are slower, less precise and ignore 90% of liner surface
